Restoration of Dalton Castle using Singleton Birch Natural Hydraulic Lime

Project:

The works to the tower primarily consisted of removal of cement pointing and repointing in lime mortar.

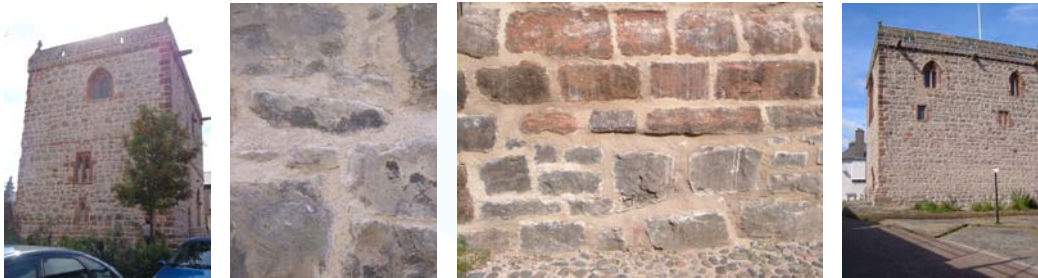
After:

As the tower is a schedule monument prior approval of a weathered sample was required. Trial panels done using a Singleton Birch NHL 2 were shown to give the right colour and physical properties. Work started in March and was completed in early August using Singleton Birch NHL 2 throughout. All the cement pointing was removed, any large voids were filled with matching stone bedded on the lime mortar and the entire tower repointed.
