# Restoration of Dalton Castle using Singleton Birch Natural Hydraulic Lime

## Project:

The works to the tower primarily consisted of removal of cement pointing and repointing in lime mortar.

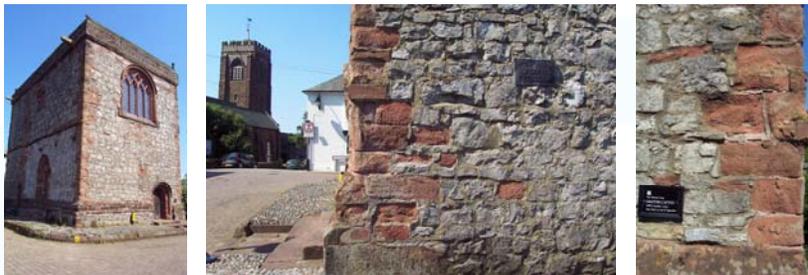
## Before:

The National Trust chose an NHL 2 to provide certain durability to the moderately exposed conditions but provide maximum breathability. Samples of mortar analysed by the Scottish Lime Centre showed a mixture of non-hydraulic to eminently hydraulic, but the Trust felt a NHL 2 was a suitable compromise to give adequate strength with the best possible breathability.

As the tower is a schedule monument prior approval of a weathered sample was required. Trial panels done using a Singleton Birch NHL 2 were shown to give the right colour and physical properties. Work started in March and was completed in early August using Singleton Birch NHL 2 throughout. All the cement pointing was removed, any large voids were filled with matching stone bedded on the lime mortar and the entire tower repointed.
